# NOTES H19.1 JOSEPH JOHN ALSTON (CHATHAM JACK)

## Following removal of the rock wall in June 2018

### NOTES ON REMOVAL OF CEMETERY WALL JUNE 2018

### NOTES ON CEMETERY MAPPING 10 OCT and 12 OCT 2019

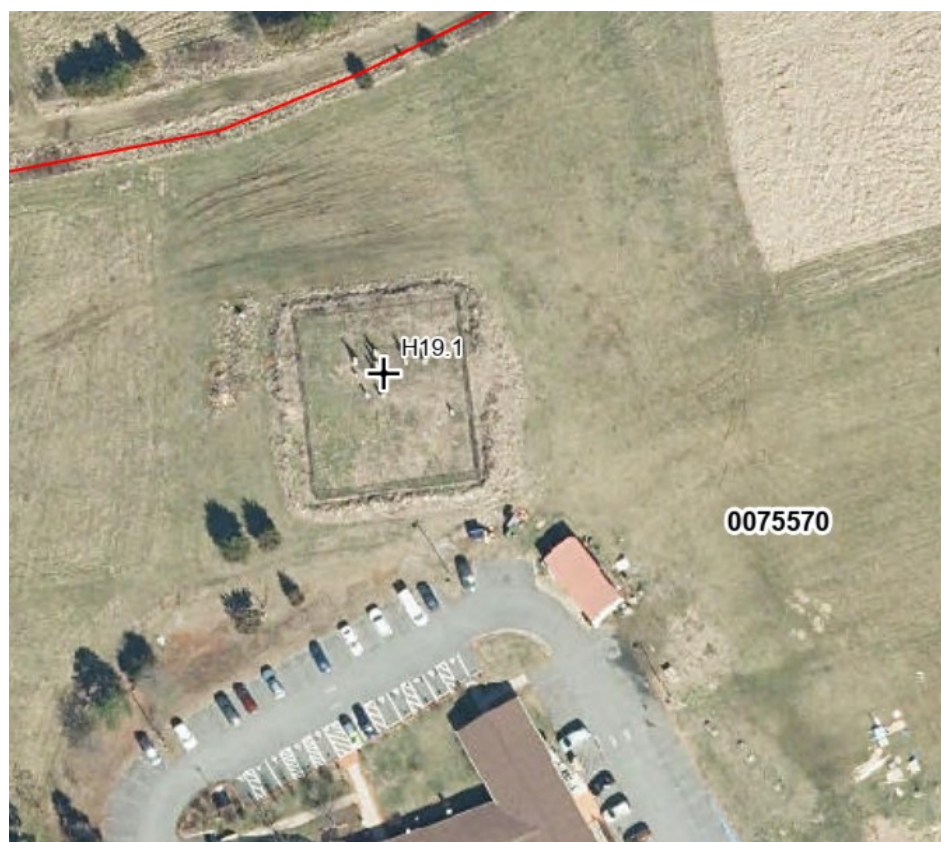
Aerial photo from 2025 Chatham GIS.

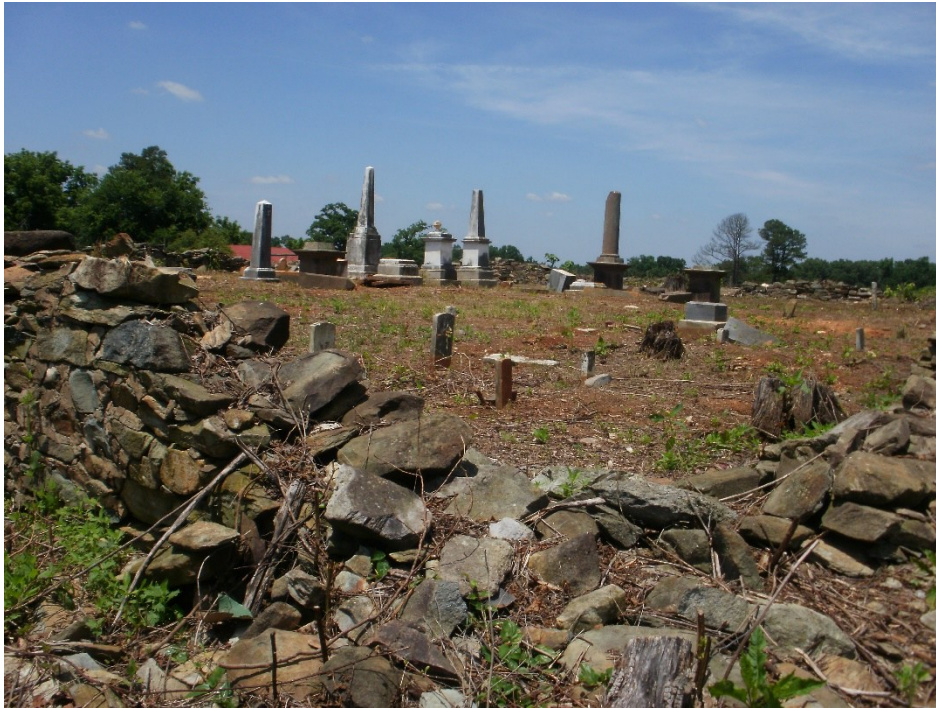
Taken 2010 by Barbara C. Pugh showing original wall

2. Using the detailed photographs from various canvassers, it appeared to have been roughly 2 to 2.5 ft wide at the base and varied in height from 3.4 to 4.0 ft tall. The most intact sections appeared to be about 4 ft at its best. Some collapse had occurred prior to the wall being removed.

3. The perimeter wall was a dry-laid stone construction (not mortared) and composed of local fieldstones (meta rhyolite). Some photographs taken by cemetery canvassers can be used as a guide for

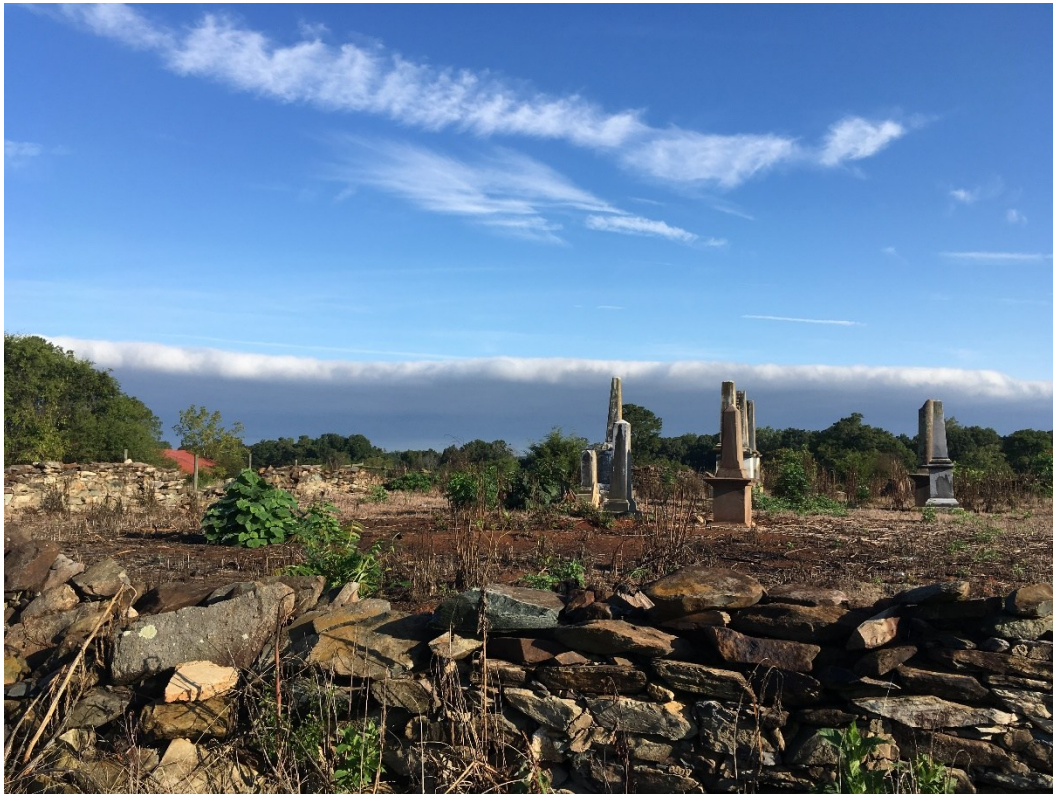
Taken 2016 by Connie McAdams showing original wall

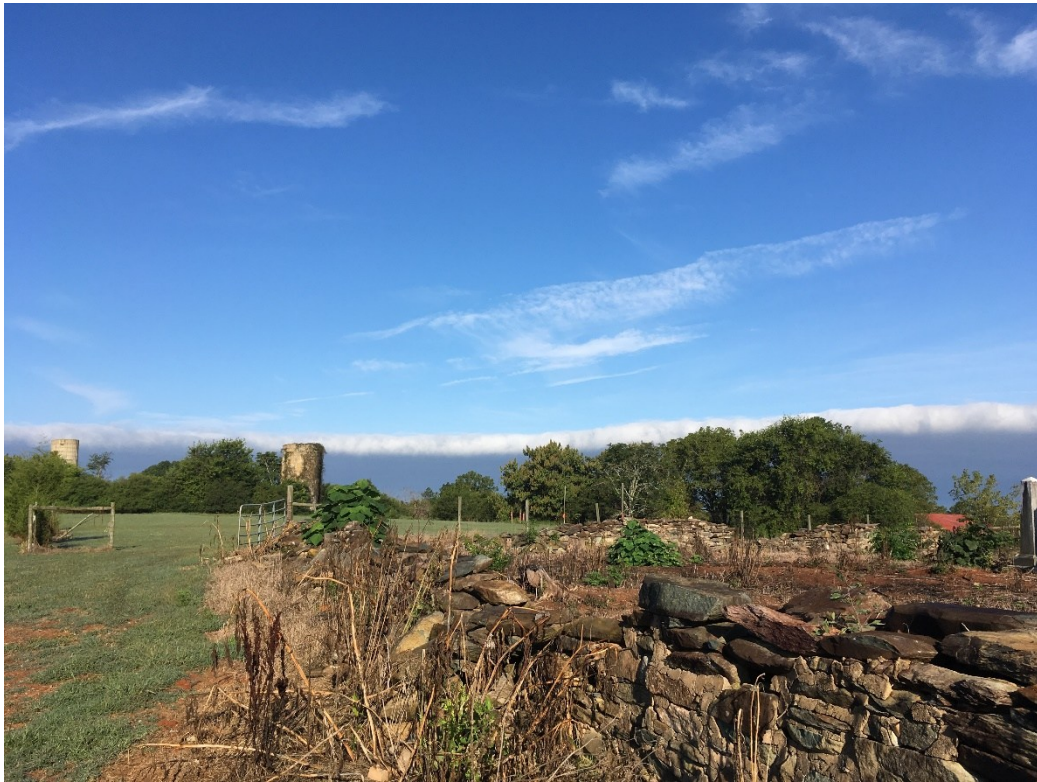
Taken 2016 by Connie McAdams showing original wall

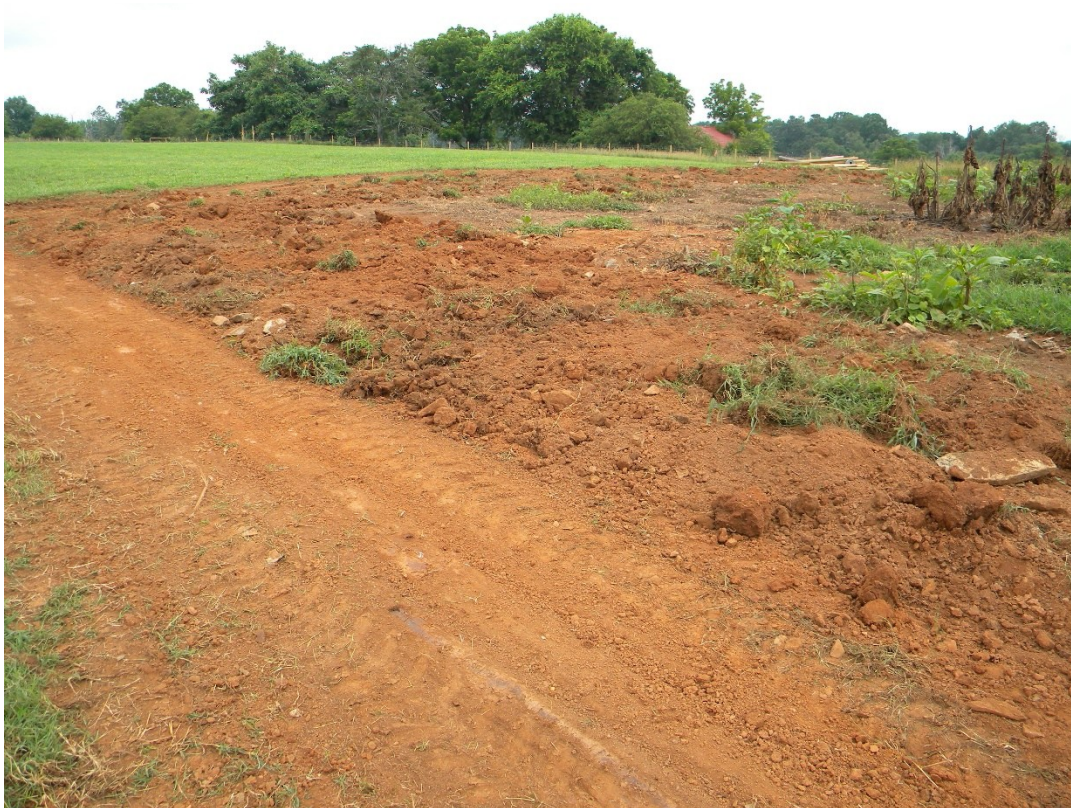
Taken 13 June 2018 by Beverly B. Wiggins showing removal of wall

In June of 2018 neighbors of the St. Julia's Catholic Church reported to CCHA that the stone wall around the Joseph John Alston cemetery had been removed with large equipment and the stones piled some distance away. Contact with the church was made immediately to let them know that the removal was inappropriate and illegal and that steps needed to be taken to protect the gravesites. Many attempts were made to discuss a possible resolution, but no satisfactory discussions were held until February of 2019, when a new priest was in place and Alston descendant Steve Brooks met with him and other church officials. Brooks was satisfied that the new priest, Father Julio, would see that the wall was rebuilt using the original stones. No progress had been made in that direction as of October 2019 when CCHA volunteers surveyed and mapped the cemetery to help guide placement of the reconstructed wall. The survey team was led by professional archaeologist, Linda Carnes-McNaughton. She was assisted by Kirk McNaughton, Jim Wiggins and Bev Wiggins. Two site visits to the cemetery were made—on 10 Oct and 12 Oct 2019. Notes from those visits and communications with Father Julio and David Daughton, who was identified as the church's manager for the wall reconstruction, follow.

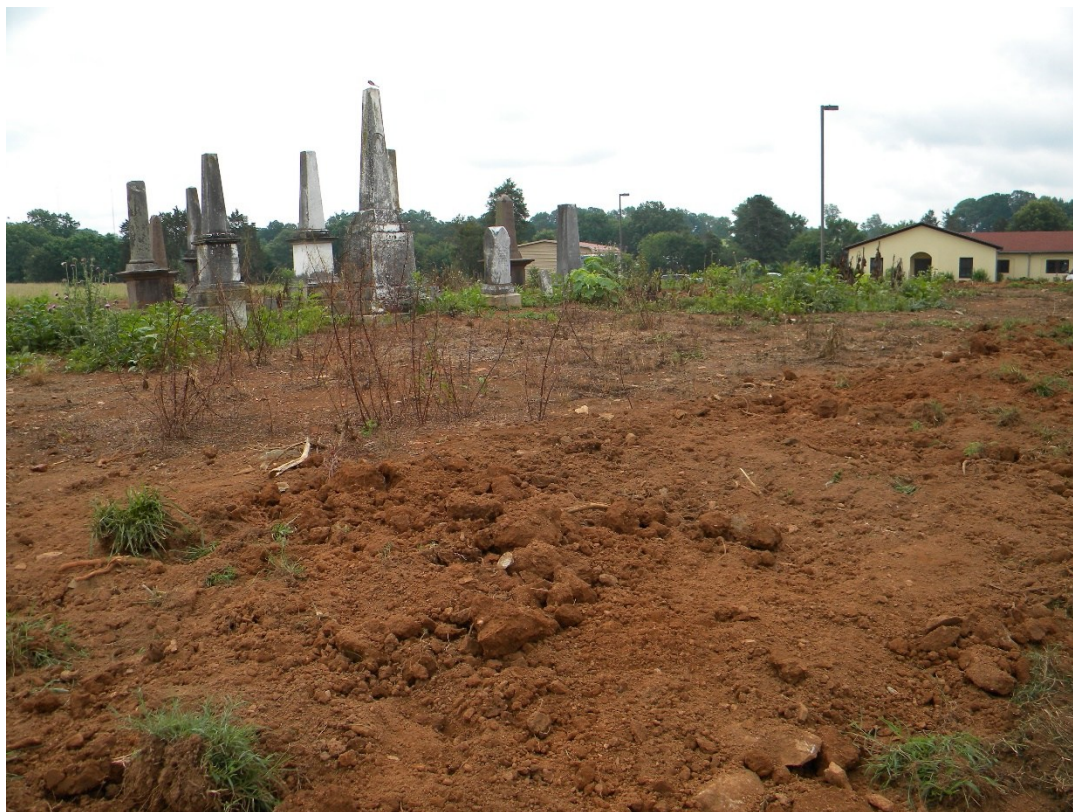
Taken 13 June 2018 by Beverly B. Wiggins showing days after removal of wall

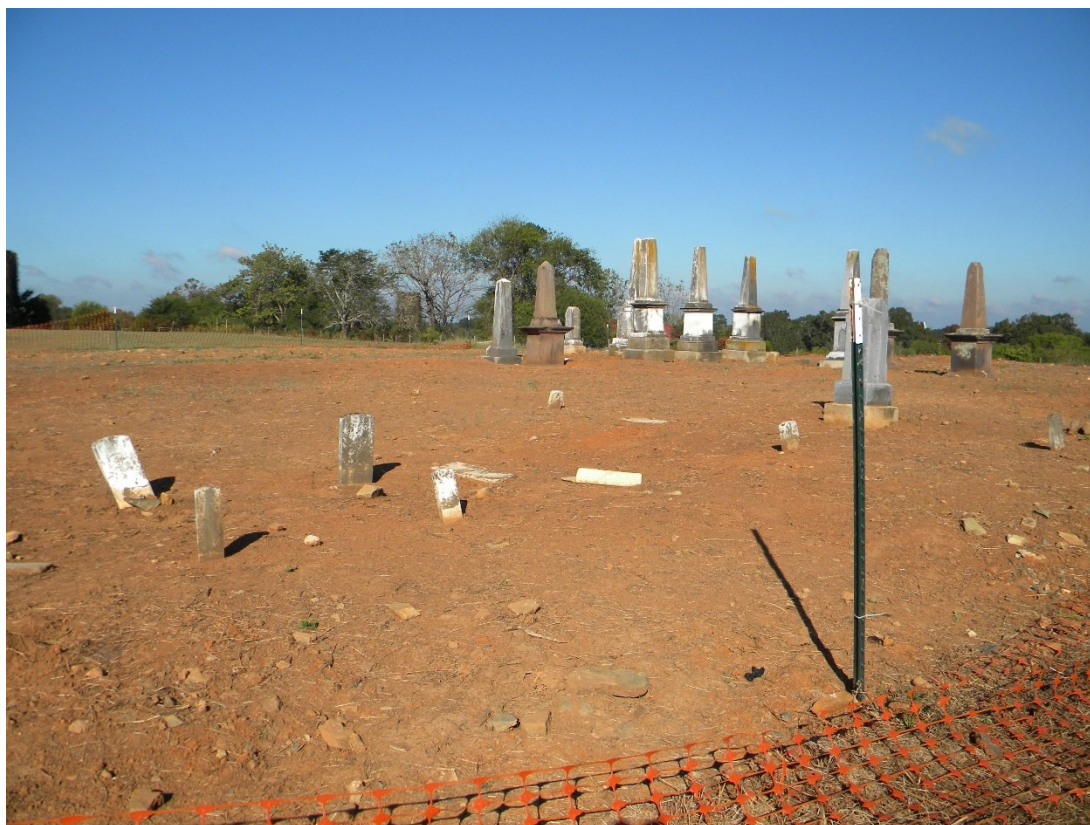
Taken 10 Oct 2019 by Beverly B. Wiggins after mapping the site

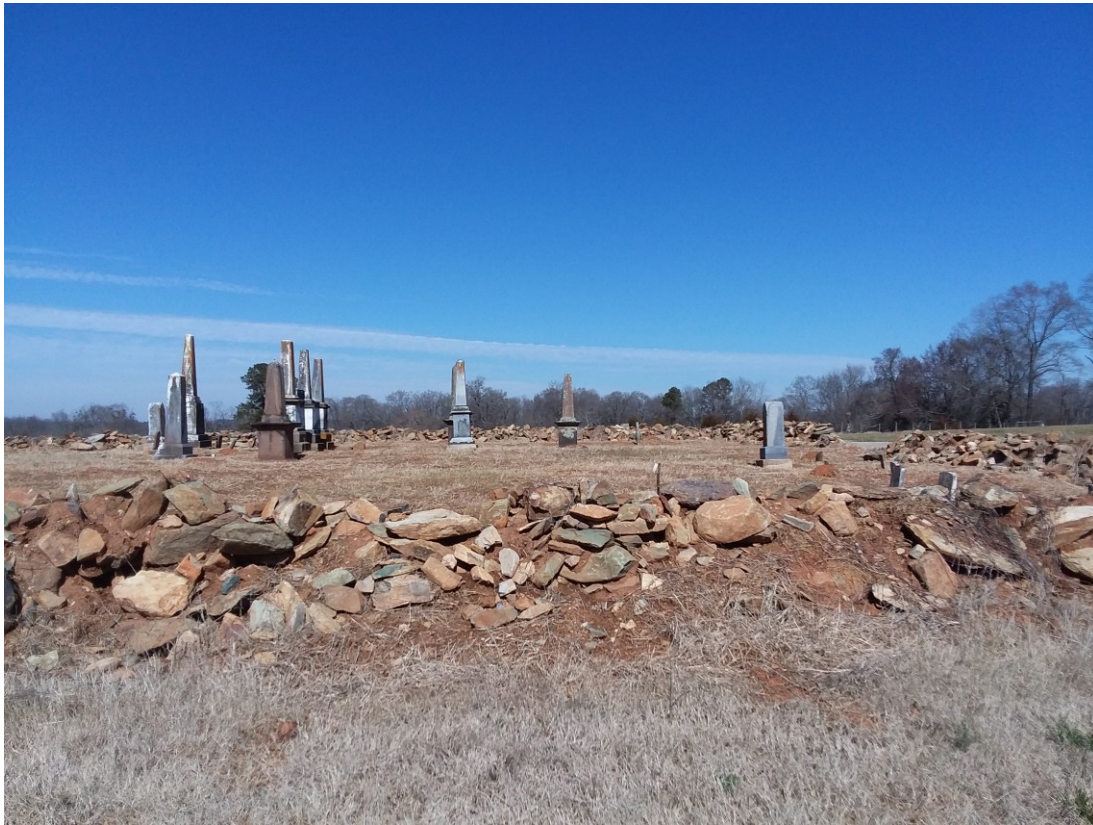
In 2021 the St Julia's Parish contracted with someone to rebuild the wall around the cemetery per the agreement with descendants. However, the contractor simply moved the rocks and soil, which had been piled at the edge of the property since the wall was removed, around the perimeter of the cemetery, an unacceptable outcome.

Taken 21 Feb 2021 by Beverly B. Wiggins after rocks from the wall were pushed back into place around the cemetery perimeter.

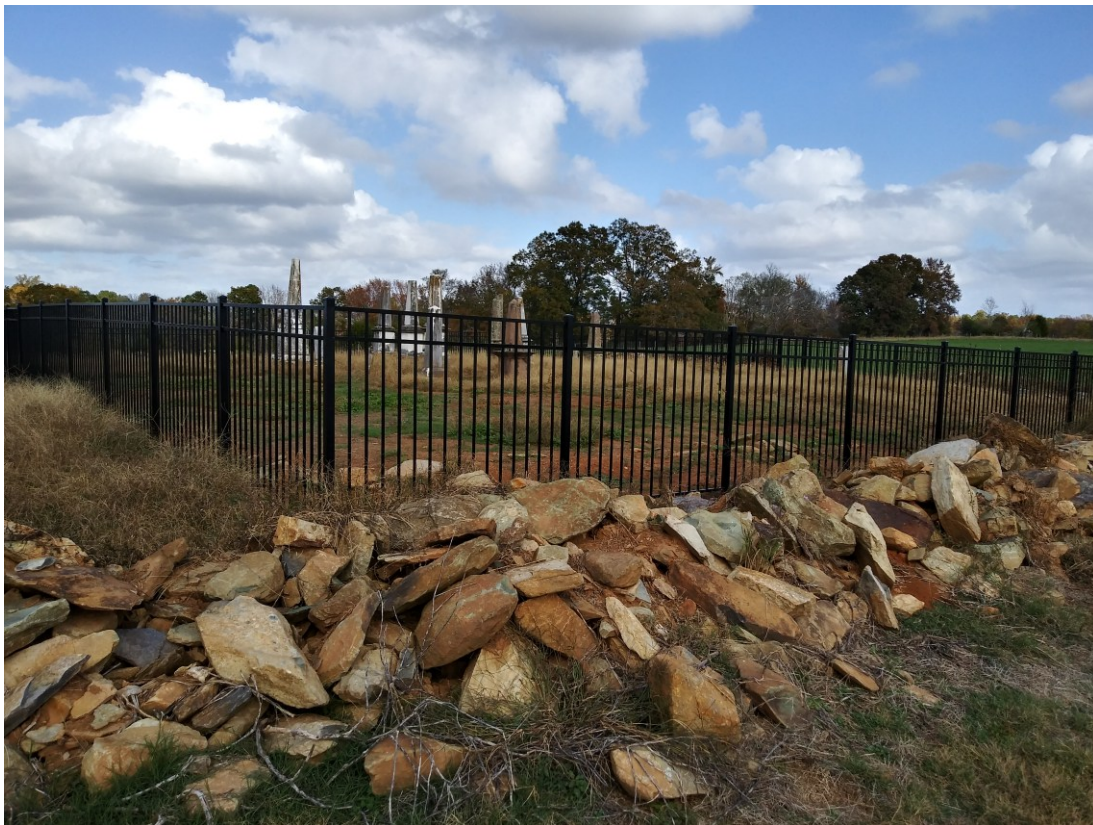
Subsequently, an agreement was reached between the Parish and descendants that alternative fencing could be used around the cemetery, and that stones from the original wall would be used to build planters and other landscaping features within and around the cemetery. A metal fence was erected in 2022, but as of June 2026, the reuse of the stones from the wall has not been accomplished.

Taken 4 Nov 2022 by Beverly B. Wiggins after a metal fence was erected inside the perimeter of the dumped stones from the original wall.
